Manhole Inspection Summary

Manhole # S47I__018MH

Insp Date: **4/23/08 11:07 AM**

Location Address: **439 s chester st**

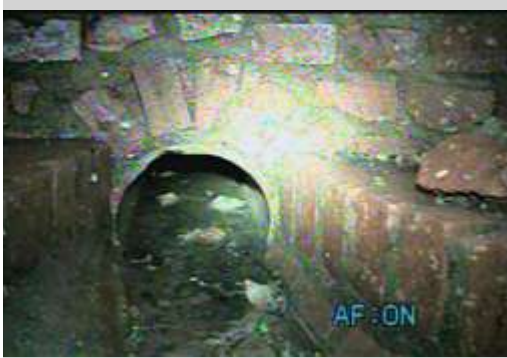
Defect 3

Condition: ☐ Sound ☐ Cracked ☐ Root Intrusion ☐ Deteriorated ☐ Leaks ☒ **Debris**

Channel Condition Debris

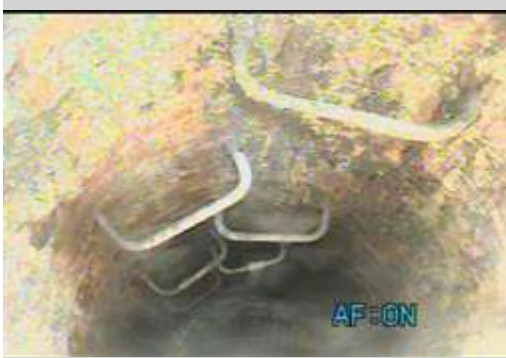
Defect 2

Steps Count: **10** Missing: **0** ☒ **Corroded**

corroded steps

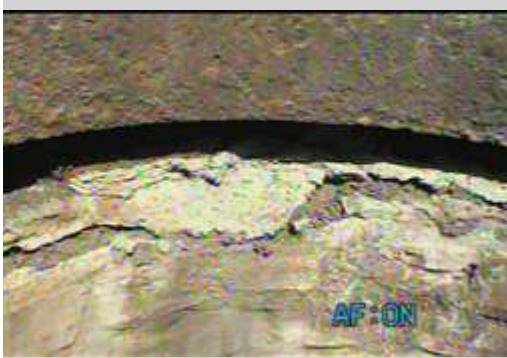
Defect 1

Chimney / Frame Adjustment ☒ Exists Material: **Brick and Concrete** ☐ Parged Height: **3** (in.)

Condition: ☐ Sound ☐ Cracked ☐ Root Intrusion ☐ Loose Brick ☒ **Deteriorated**

deteriorated chimney, frame adjustment

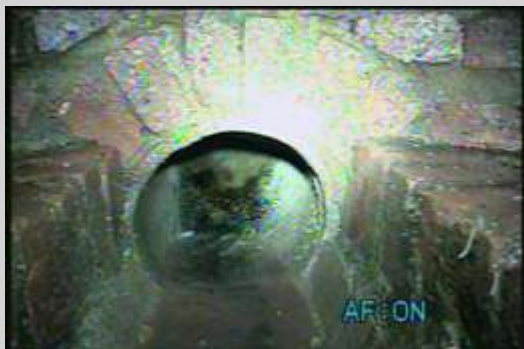
5 O'Clock Inflow

8 in. Circular Gravity Sewer
Pipe In @ 5 O'Clock

Drop In @ 5 O'Clock

Drop: Inside Direct

Drop Condition: Open
